Western Cape Provincial Coastal Access Audit – West Coast Municipal District

APPENDIX 1- MAPS AND TABLES

October 2019

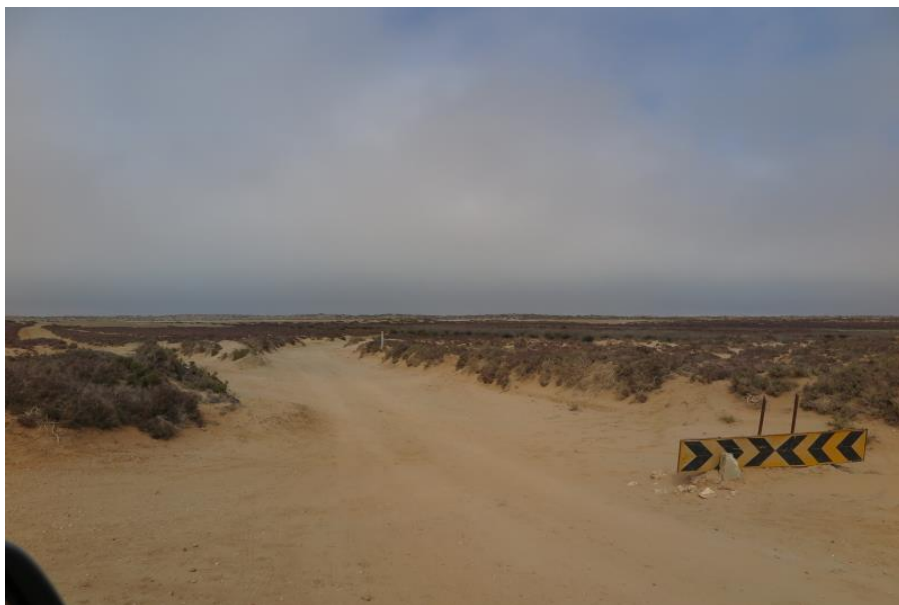
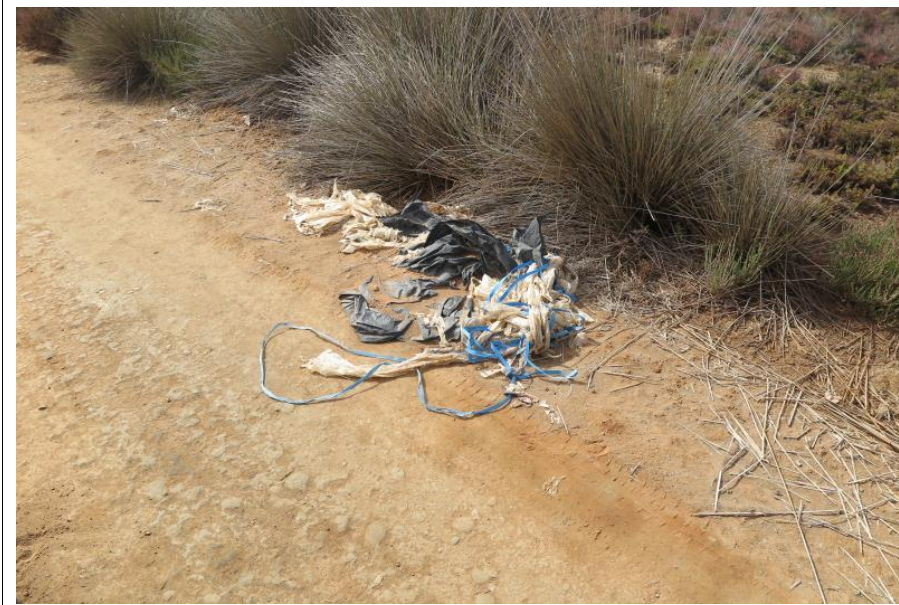
Town/area	Between Oliphants-rivier and Strand-fontein
Site Ref:	Str 02

results in large amounts of waste being left behind even though refuse bins are provided. There is also extensive damage to the wetlands and adjacent dunes. This results in conflict between the users, environmental lobby and local authority.

Littering in the veld takes place near to the Launching site and water reservoir of the Municipality.

Needs:	<p>There is clearly a need for recreational facilities in this estuary and prohibition is clearly not effective. The Local Authority is encouraged to develop an approach which caters for this need without the need for extensive policing. This will require involving local communities to assist in the management of the area once mixed uses have been catered for. There is a need for further investigations to resolve the conflict without further damage to the environment.</p> <p>Existing signage for ORV driving and environmental education needs to be upgraded.</p> <p>Life Saving Services needs to be in place during peak holiday season.</p> <p>The Labyrinth of Memories must be filled up with broken shells frequently and signage on the background of the labyrinth will have to be replaced from time to time as needed due to weathering in harsh weather.</p> <p>The existing litter dumping site needs to be properly rehabilitated and monitored in order for dumping not to take place in the future.</p>

Recommendations	<p>Province needs to enter into an agreement with the Municipality using the Intergovernmental Relations Framework Act, in order to co-ordinate the effective implementation of the Olifantsriver Estuary Management Plan.</p> <p>The Local Authority and DPW is encouraged to develop an approach which caters for this need without the need for extensive policing. This will require involving local communities to assist in the management of the area once mixed uses have been catered for. There is a need for further investigations to resolve the conflict without further damage to the environment.</p>

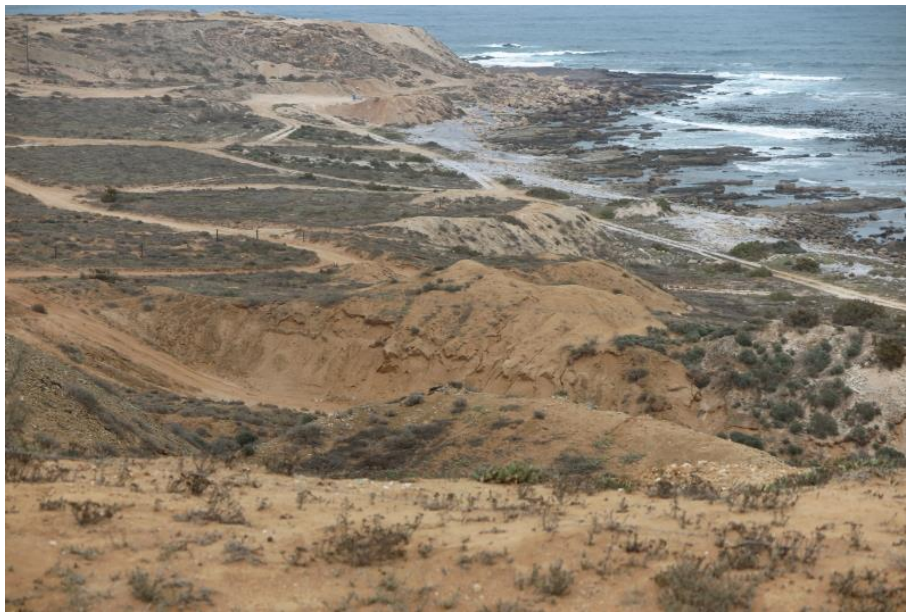
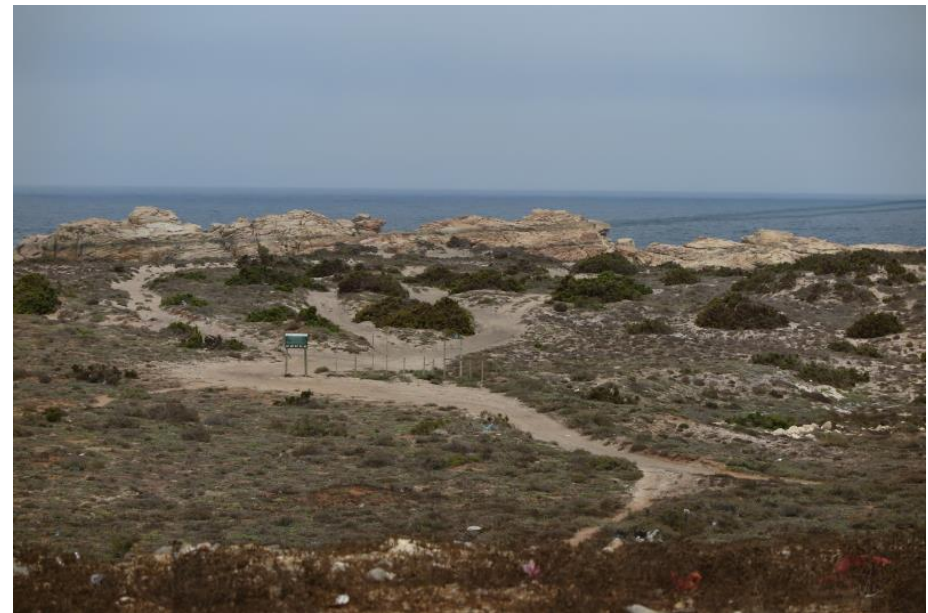
Description:	<p>Extensive medium-height sandy dunes grading to rocky shoreline. Large areas of dune and associated vegetation impacted by 4X4 vehicles</p> <p>This sector is a stretch of private land through which public access to the coast is permitted through prior arrangement. Roadways have also been opened by means of pulling up fences or gates to provide public access- presumably without the landowner's permission. An extensive network of 4x4 tracks and roads across and along the dunes is evident in the aerial images indicating that this area is well used for 4X4 and fishing among other activities.</p> <p>It is characterised by unconsolidated vegetated dunes down to a narrow beach. The dunes are medium height and the terrain is very broken. The vegetation is, in general, in good condition but frequent 4X4 passage results in damage to the structure of the dunes and the vegetation.</p>
---------------------	---

<p>The prohibition on ORVs on beaches remains in force but some mechanism must be found to manage the 4X4 c and fishing communities to prevent further damage to private property and the environment.</p> <p>This will require a collaborative and consultative approach but in view of the need for such amenities it is regarded as urgent.</p> <p>Although Abalone farming is projected along this stretch of coast reasonable public coastal access must still be available for the public .</p>					
Needs:	The Wandering Whale labyrinth needs to be filled up with shell, bins needs to be cleaned regularly and signage as well as bankies needs to be replaced on a regular basis.					
Recommendations	This has been classified as a conflict area as a consequence of illegal activities (4X4 on the beach) and illegal access across private property.					
Priority Action Items						
Conflict	Environmental degradation/ damage	Safety and security	Identified need	Maintenance required	Further investigations required	Illegal activities

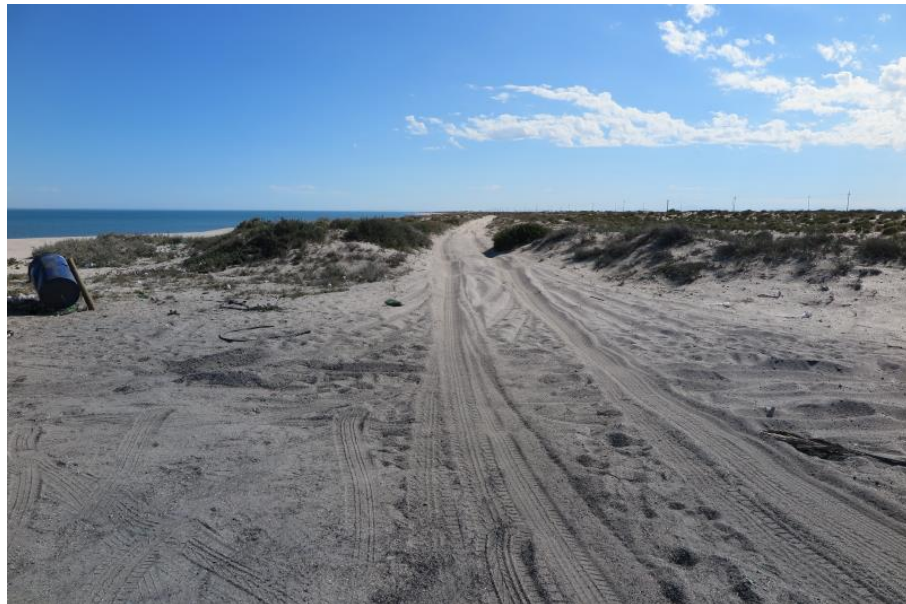
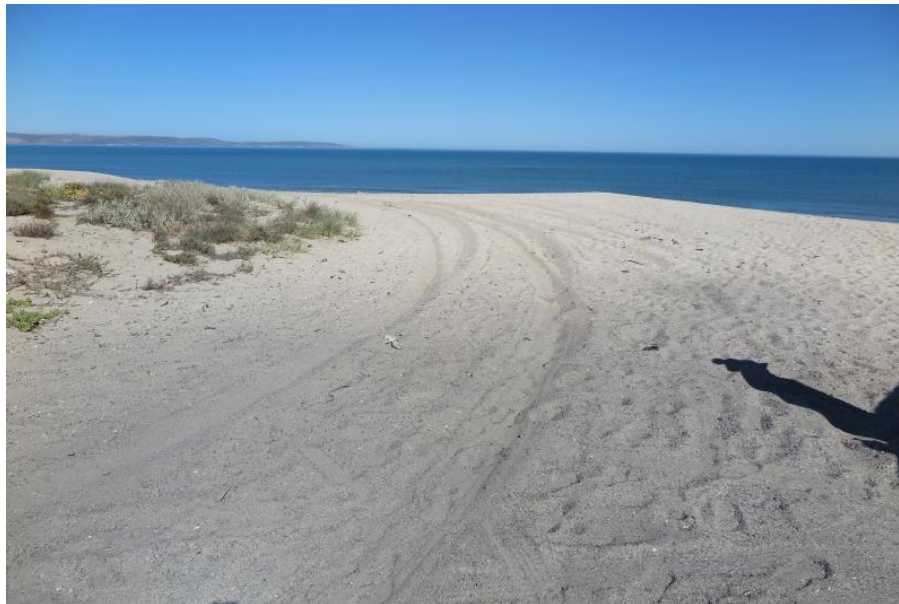
Town/area	Dwarskersbos to Laaiplek	Colour	Characterisation	Colour	Characterisation
		Access in conflict	X	Pedestrian access	
		Restricted Access		Nature reserve access	
		Vehicle access		No formal access	
Site Ref:	Dwa 04				
Description:	<p>Sandy shoreline with very low vegetated dunes.</p> <p>The stretch from Dwarskersbos to Laaiplek is primary privately owned and comprises low undulating vegetated dunes front onto a sandy shoreline. Formal access is provided to the beach at Soverby Lapa. In addition, a gravel road runs parallel to the shoreline and is supplied with refuse bins. Local residents related that this road is well used by fishermen.</p>

Facilities provided:	Refuse bins					
Planned uses catered for:	Fishing, swimming?					
Concerns:	If the gravel road is a formal designated road, vehicles may use it even though it is in the coastal zone. If not, all such vehicular activity unless accompanied by a permit is illegal. Although numerous side roads have developed from this gravel road to the beach itself, there is no significant damage to the dunes or vegetation at this stage.					
Needs:	There is clearly a need to access this stretch of coastline.					
Recommendations	Nil					
Priority Action Items						
Conflict	Environmental degradation/ damage	Safety and security	Identified need	Maintenance required	Further investigations required	Illegal activities
X			X	X	X	?

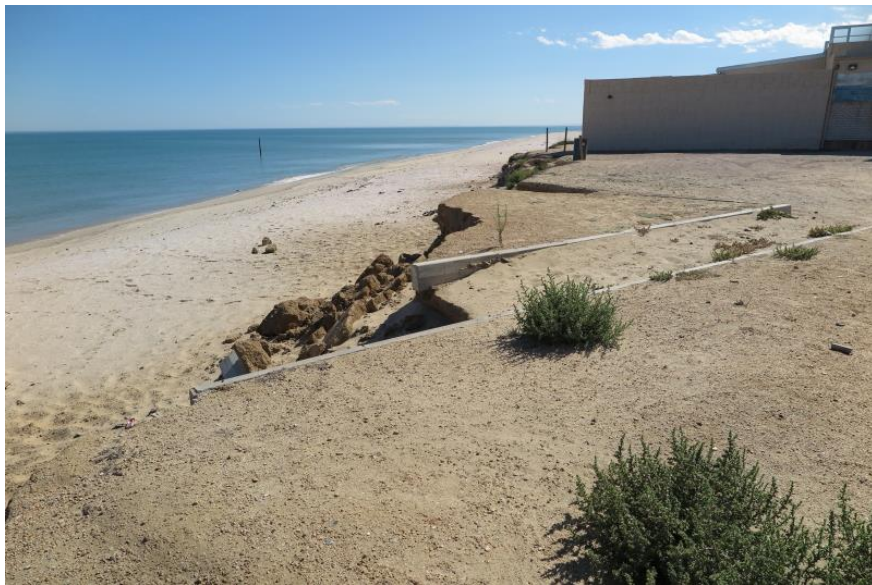
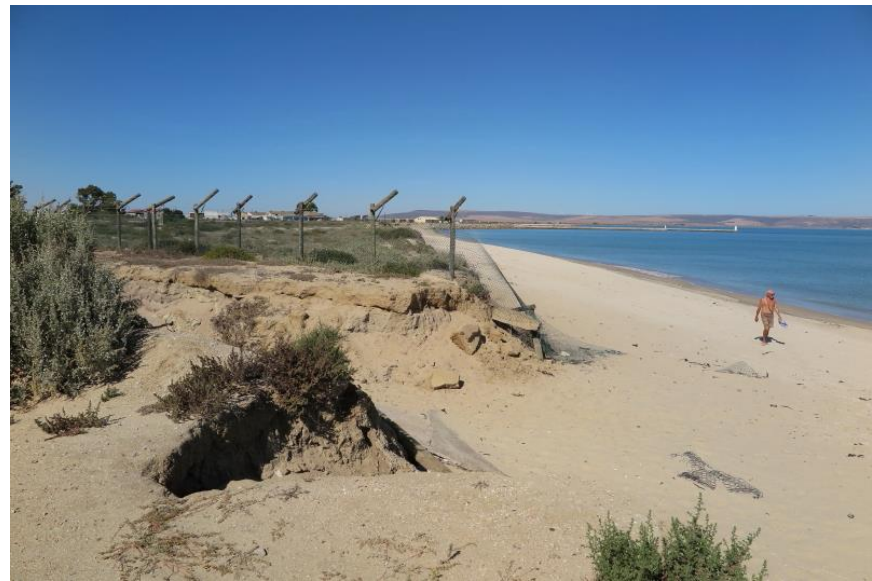
Description:	<p>Sandy beach seaward of chalets. Minimal coastal vegetation- dunes flat.</p> <p>This stretch is a resort with chalets and camping facilities as well as a formal parking area to the north, all of which provide access to the sandy beach area.</p> <p>The resort is largely derelict and little used except for the parking.</p>					
Facilities provided:	Ablutions, refuse bins, accommodation, parking, sign boards					
Planned uses catered for:	Overnight stay, swimming, fishing, swimming					
Concerns:	The resort is not well maintained and could pose a safety and security hazard to users.					
Needs:	Nil					
Recommendations	The resort needs to be repaired and maintained.					
Priority Action Items						
Conflict	Environmental degradation/ damage	Safety and security	Identified need	Maintenance required	Further investigations required	Illegal activities
		X		X

Needs:	Nil					
Recommendations	Maintenance of facilities required.					
Priority Action Items						
Conflict	Environmental degradation/ damage	Safety and security	Identified need	Maintenance required	Further investigations required	Illegal activities
				X

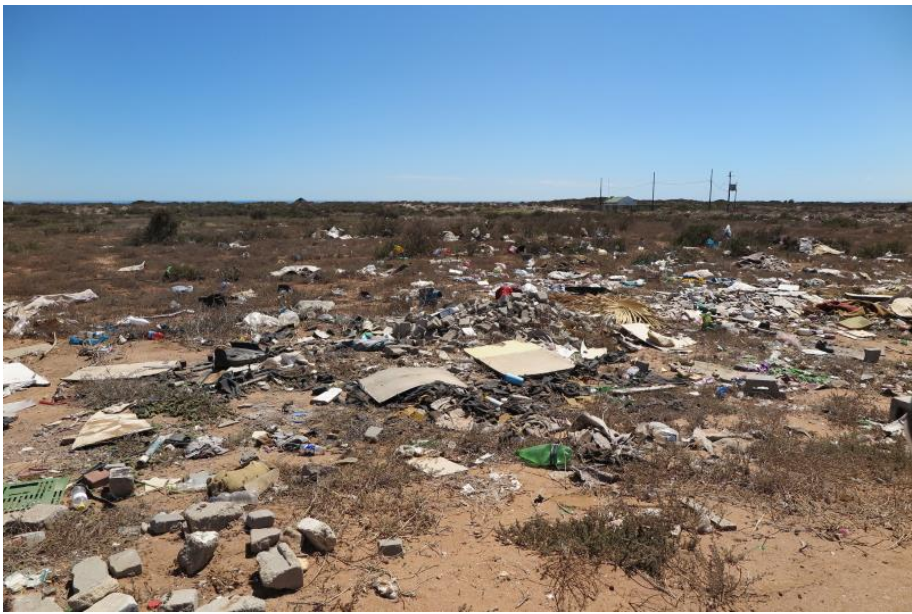
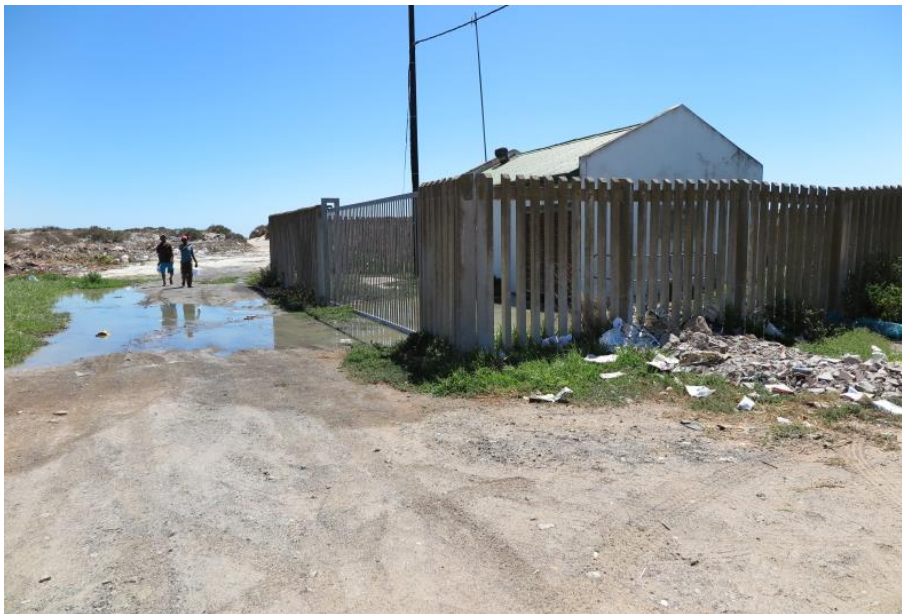
Colour	Characterisation	Colour	Characterisation	Access in conflict		Pedestrian access		Restricted Access		Nature reserve access		Vehicle access		No formal access	X
Colour	Characterisation	Colour	Characterisation															
Access in conflict		Pedestrian access																
Restricted Access		Nature reserve access																
Vehicle access		No formal access	X															
Site Ref:	Lai 01																	
Description:	<p>Municipal (?) land with undulating , medium height vegetated dunes backing the sea.</p> <p>There is a gravel track running from Laingville to the water treatment works and numerous other tweespoor tracks running from that roadway to the coast through the dunes. A further track runs along the rear of the vegetated dune to the farms in the north-east.</p>

Planned uses catered for:	Nil					
Concerns:	The informal paths traversing the dunes are resulting in damage to the dune structure and vegetation. In addition, large scale littering was in evidence all along the paths. The sewage works were also overflowing across the main access path leading to the beach.					
Needs:	Public access is catered for directly in front of Laingsville, these extra access points are not necessary.					
Recommendations	The informal/ unregulated access points should be closed					
Priority Action Items						
Conflict	Environmental degradation/ damage	Safety and security	Identified need	Maintenance required	Further investigations required	Illegal activities
	X			X		X

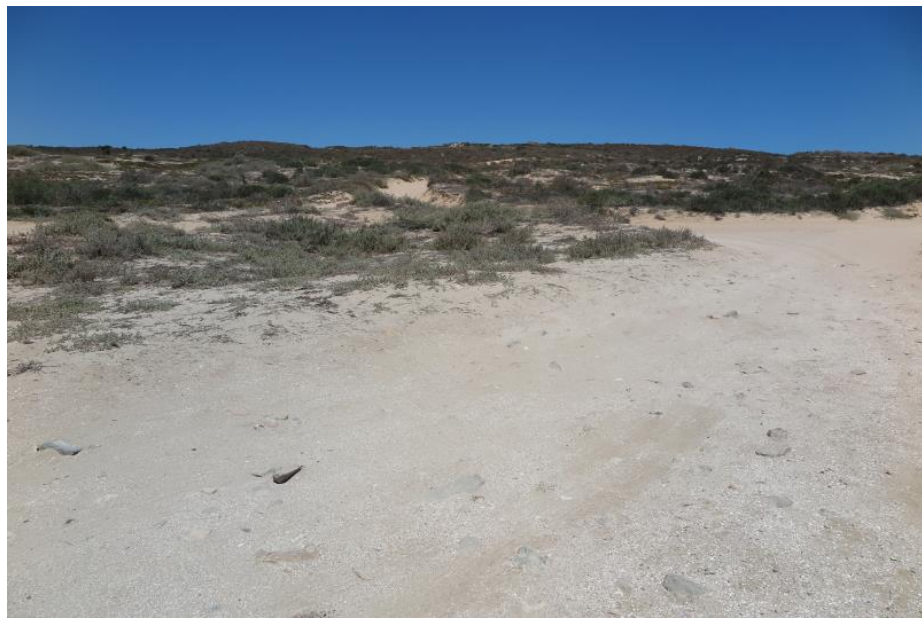
Site Ref:	Duy 02																				
Description:	Small sandy bay bounded by a rocky headland to the West. Heavy impact of 4X4 vehicles in the area.

Planned uses catered for:	Fishing and swimming, hiking					
Concerns:	Vegetated areas are being impacted by the proliferation of gravel parts and tweespoor.					
Needs:	Formalised infrastructure?					
Recommendations	The number of separate paths is excessive and should be reduced					
Priority Action Items						
Conflict	Environmental degradation/ damage	Safety and security	Identified need	Maintenance required	Further investigations required	Illegal activities
	X			X		?

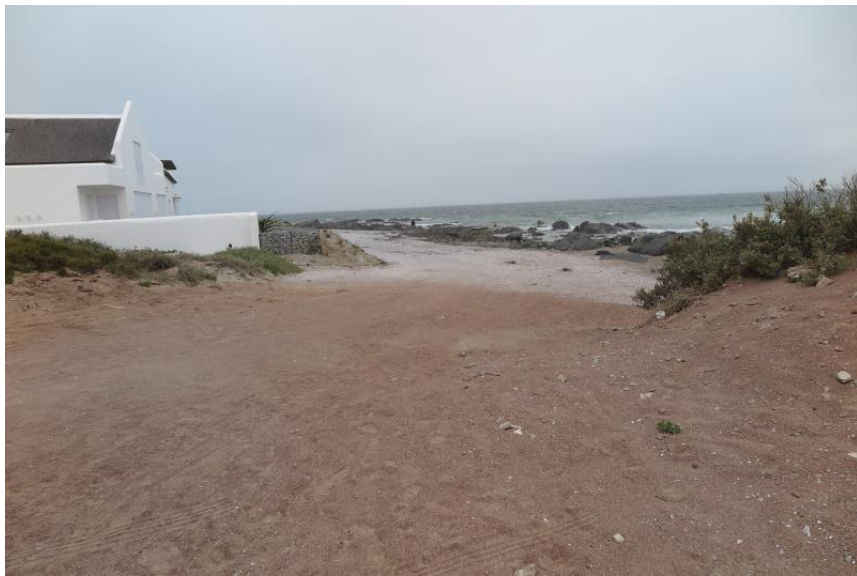
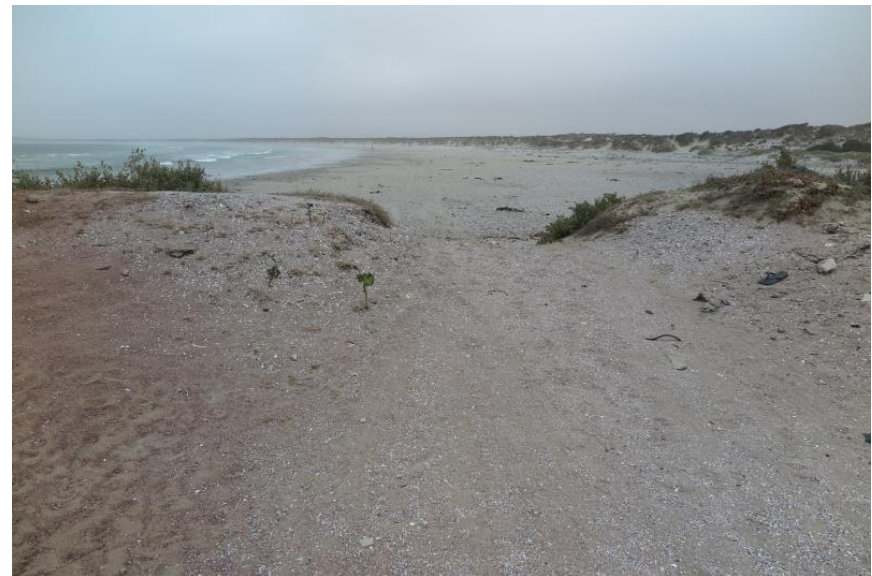
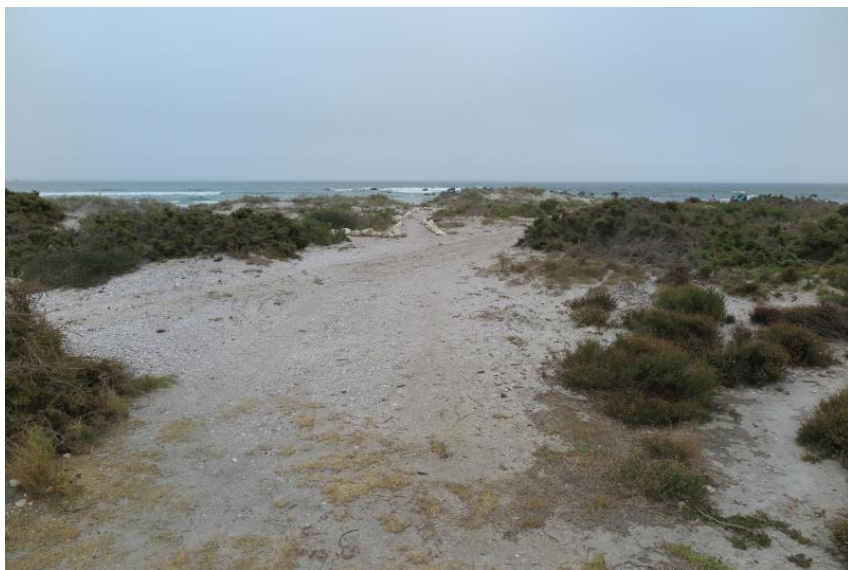
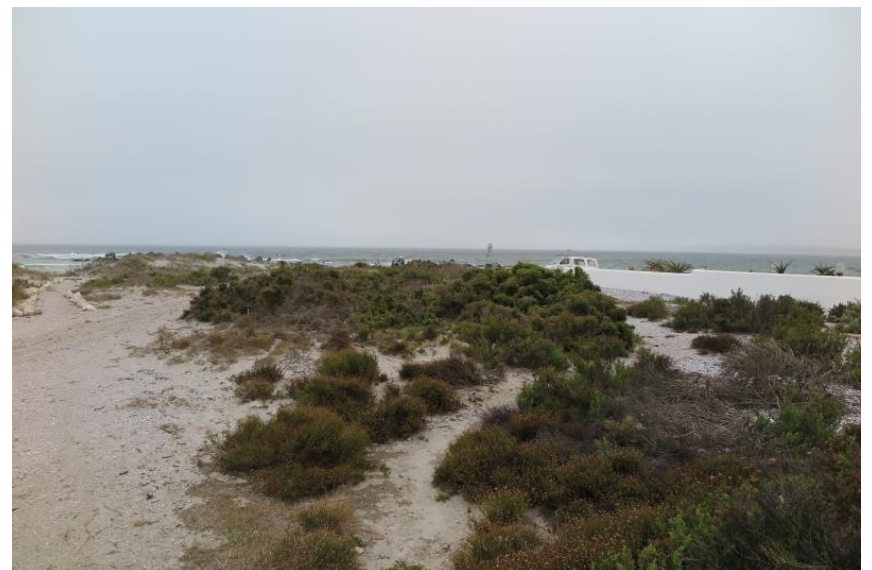
Town/area	Paternoster	Colour	Characterisation	Colour	Characterisation	
Site Ref:	Pay 03	Access in conflict	X	Pedestrian access		
		Restricted Access		Nature reserve access		
		Vehicle access		No formal access		
Description:	Sandy beach, river mouth. Riparian vegetation sparse. Private land with restricted public access.					
Facilities provided:	Nil for the public					
Planned uses catered for:	Nil for the public					
Concerns:	Nil					
Needs:	Nil					
Recommendations	Nil					
Priority Action Items						
Conflict	Environmental degradation/ damage	Safety and security	Identified need	Maintenance required	Further investigations required	Illegal activities

Facilities provided:	Nil – resulting in the dunes being used for changing and ablutions.					
Planned uses catered for:	Nil – private property					
Concerns:	There are two areas of concern at this point. Firstly, access onto the beach via the two private erven. Secondly parking in a vegetated area to the northwest of the houses. There is evidence that this parking area is also used for vehicular access to the beach. Provision of controlled access to the beach at this point must be investigated as there is clearly a need for it.					
Needs:	Nil					
Recommendations	This is a conflict area. The historical access must be investigated and ongoing access resolved.					
Priority Action Items						
Conflict	Environmental degradation/ damage	Safety and security	Identified need	Maintenance required	Further investigations required	Illegal activities
X			X	X	X	X

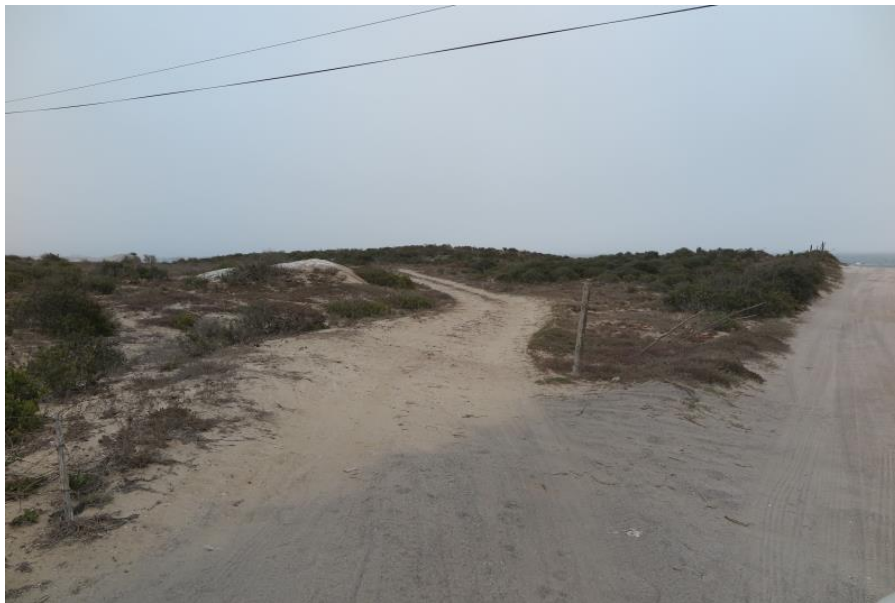
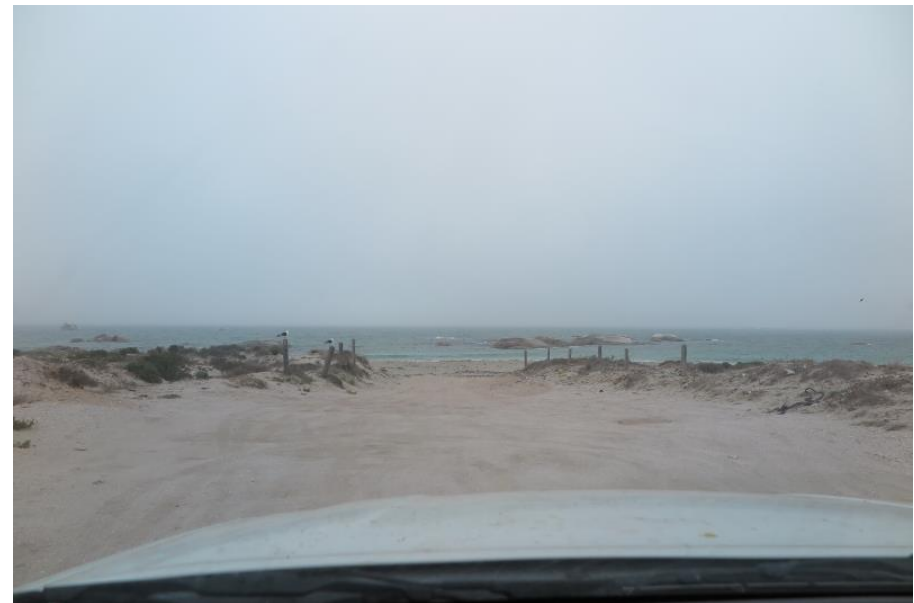
Needs:	There is clearly a need for coastal access in this sector but the lack of formal provision of facilities (even parking areas) has resulted in the public making tracks and paths at will.					
Recommendations	Coastal access in this sector needs to be formalised and the number of paths and roads reduced.					
Priority Action Items						
Conflict	Environmental degradation/ damage	Safety and security	Identified need	Maintenance required	Further investigations required	Illegal activities
	X		X	X

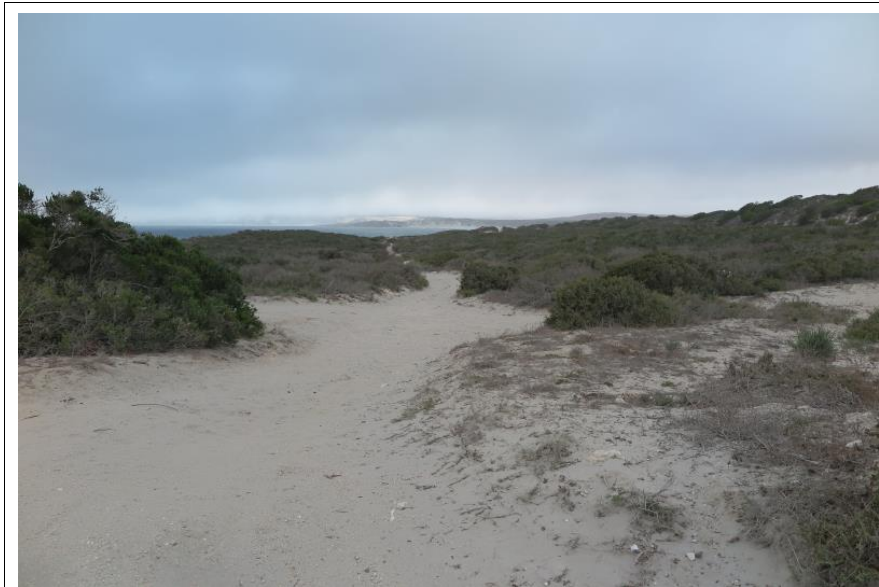
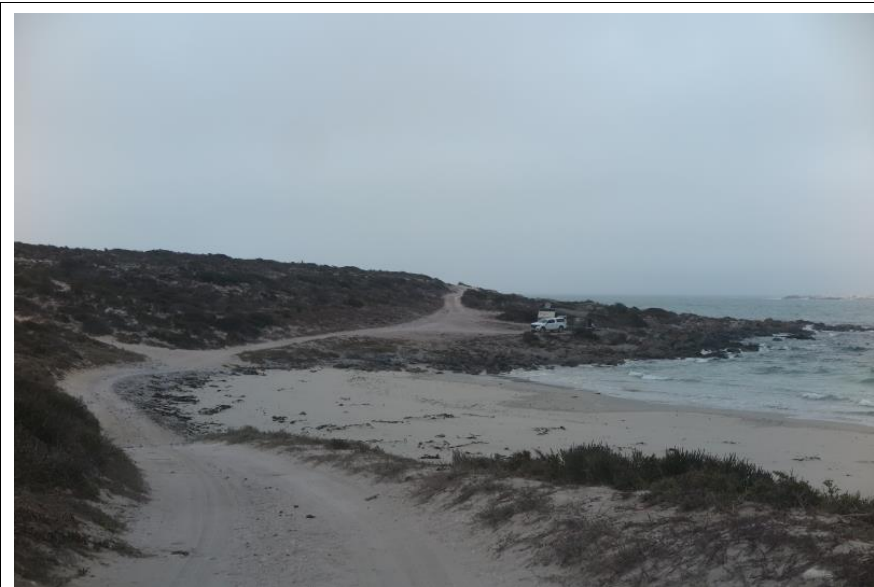
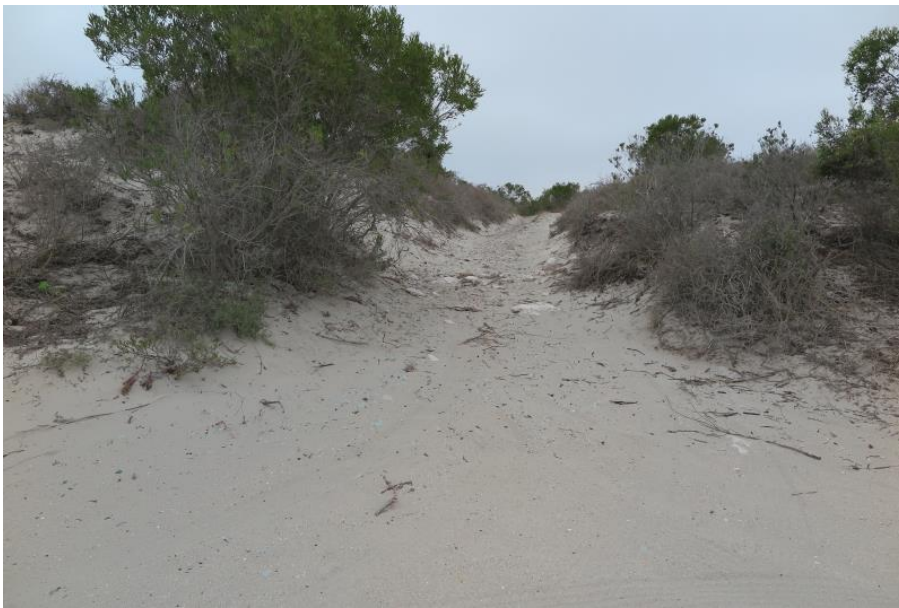
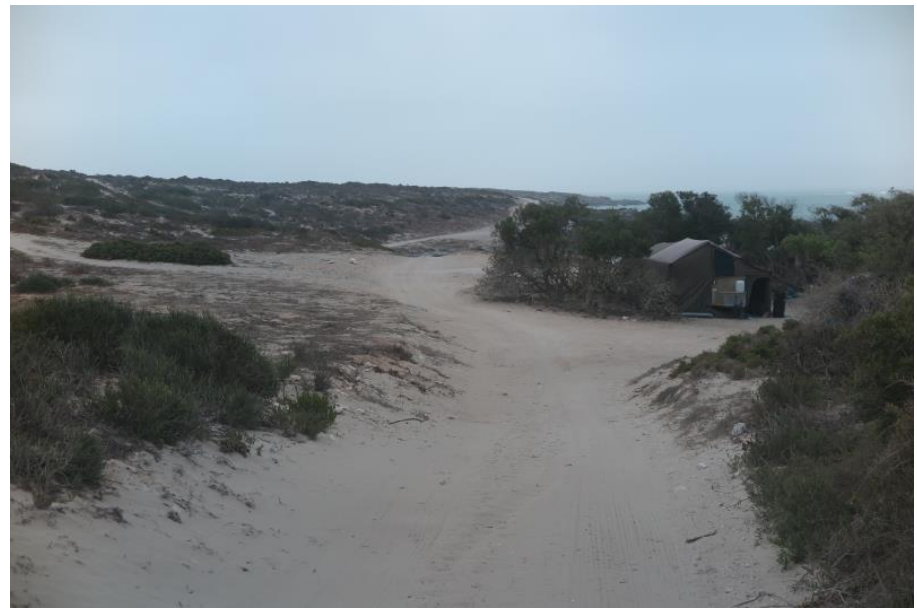
Town/area	Noorwes-baai					
Site Ref:	Nor 01	Colour	Characterisation	Colour	Characterisation	
		Access in conflict		Pedestrian access		
		Restricted Access	X	Nature reserve access		
		Vehicle access		No formal access		
Description:	Mixed coastline with sandy beaches interspersed with rocky outcrops. Extensive mobile dune fields traversed by gravel roads in places. Extent of impact could not be determined as access was not possible. Private property no public coastal access					
Facilities provided:	Nil					
Planned uses catered for:	Nil					
Concerns:	There are numerous vehicle tracks and roads running parallel to the coastline with radial pathways to the shoreline. Since these areas could not be inspected there is no way of being certain whether environmental damage has occurred.					
Needs:	Feedback from stakeholders indicates that eh sandy beaches in this area used to be available to trek fishermen but are now closed. They need these sandy beaches only at specific times of the year when the fish schools are running. Denied access means that they cannot fill their fishing quotas.

Needs:	This is a well known wild-camping and fishing site. Its presence and associated activities are widely publicised in the social media. There is clearly a need for this sort of “venue” for both wild-camping and 4X4 adventuring.					
Recommendations	It is understood that diverse land ownership is an impediment to enforcement. However an approach should be developed as matter of urgency to prevent further damage to the dunes.					
Priority Action Items						
Conflict	Environmental degradation/ damage	Safety and security	Identified need	Maintenance required	Further investigations required	Illegal activities
X	X		X		X	X

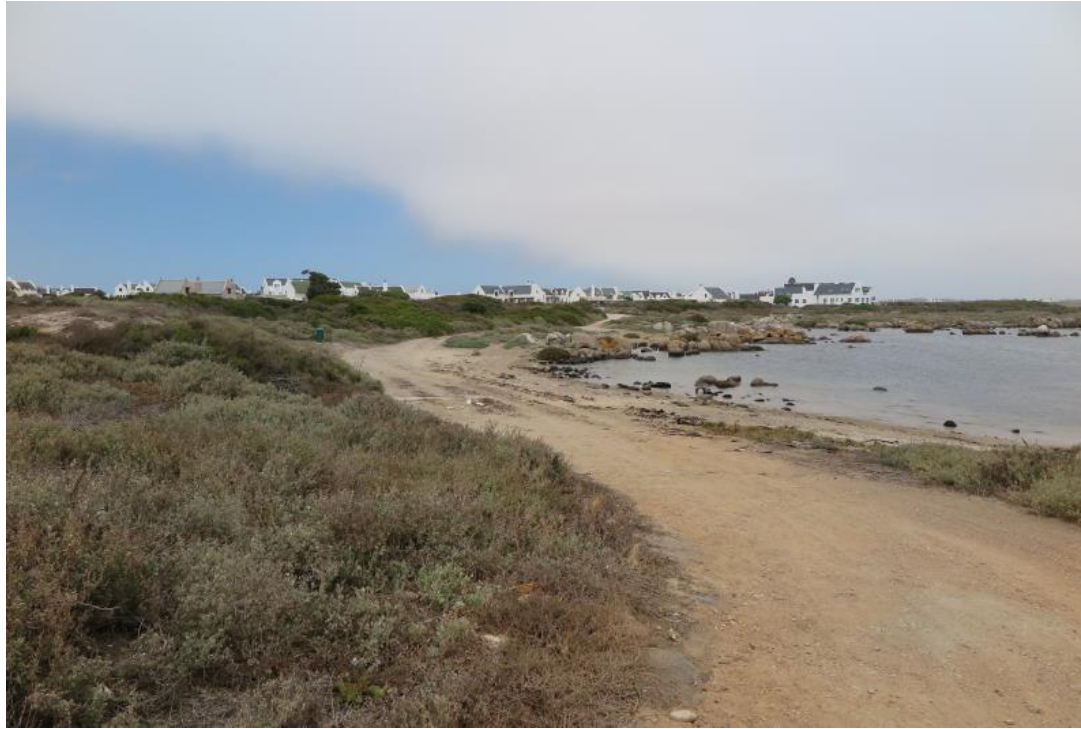
Town/area	Jacobsbaai	Colour	Characterisation	Colour	Characterisation
		Access in conflict		Pedestrian access	
		Restricted Access		Nature reserve access	
		Vehicle access		No formal access	X
Site Ref:	Jac 02				
Description:	Rocky shoreline with two small rocky pocket bays. Vegetated dunes separate the sea from the houses. No formal coastal access provision. A gravel runs parallel to the shoreline.				
Facilities provided:	Nil				
Planned uses catered for:	Nil- assumptions are made that fishing, swimming and boating are permitted but no formal facilities are provided in this sector.				
Concerns:	The proliferation of informal paths and roadways are not desirable for environmental sustainability. They should be formalised into a smaller number and the extra paths closed. The gravel road running on the shore line adjacent to Wild Current Street should be closed.

Needs:						
Recommendations	The proliferation of informal paths and roadways are not desirable for environmental sustainability. They should be formalised into a smaller number and the extra paths closed. The gravel road running on the shore line adjacent to Wild Current Street should be closed.					
Priority Action Items						
Conflict	Environmental degradation/ damage	Safety and security	Identified need	Maintenance required	Further investigations required	Illegal activities
	X			X

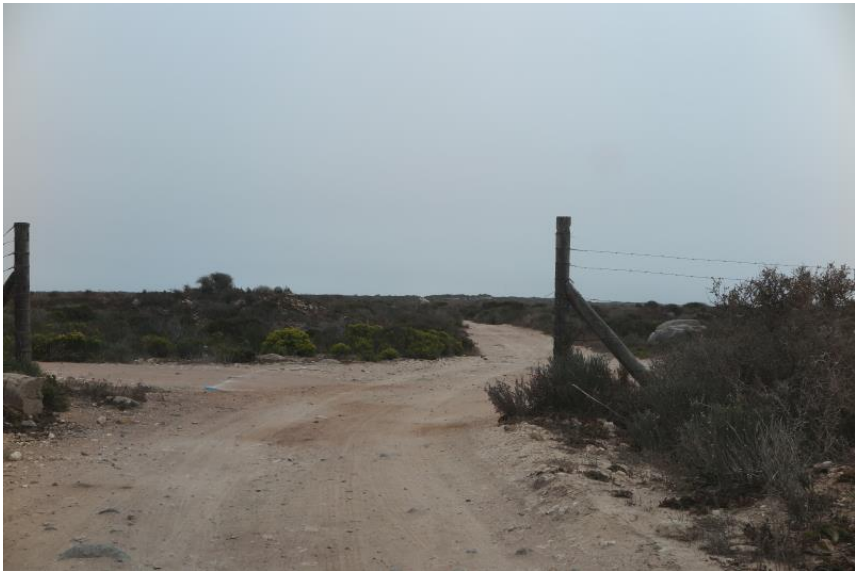
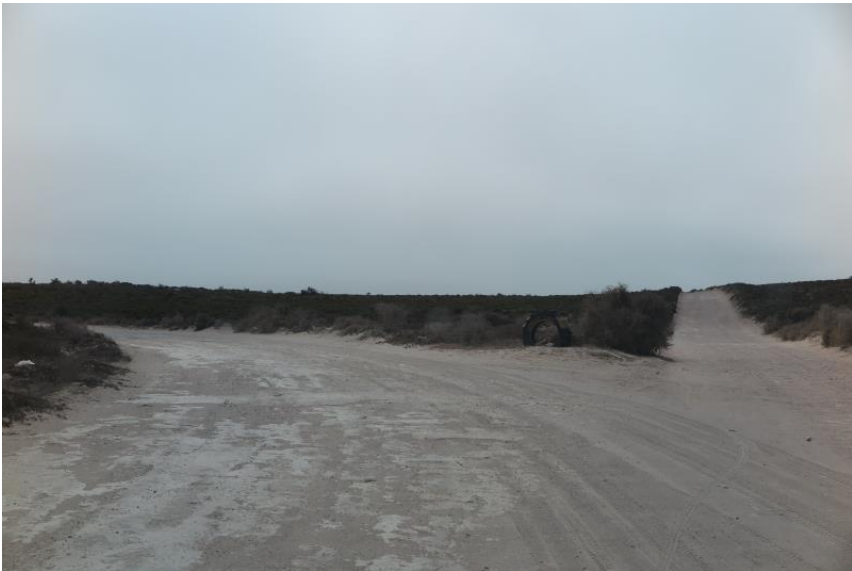
Town/area	Jacobsbaai				
		Colour	Characterisation	Colour	Characterisation
		Access in conflict		Pedestrian access	
Site Ref:	Jac 06	Restricted Access	X	Nature reserve access	
		Vehicle access		No formal access	
Description:	Mixed coastline. Rocky shoreline to the north grading to a long sandy beach to the south. Inland dunes are low and vegetated. Private property, Public coastal access restricted. A well maintained and gravel road provides access from Jacobsbaai to Saldanha. Evidence of frequent use. Numerous gravel tracks and paths parallel to and down to the shoreline.				
Facilities provided:	Nil				
Planned uses catered for:	Nil				
Concerns:	The gravel roads and paths are unregulated and will proliferate if not managed. Feedback from a stakeholder is that access to historic fishing and swimming sites has been denied by the private developments.

Needs:		Access to the coastline for fishing and picnicking.				
Recommendations						
Priority Action Items						
Conflict	Environmental degradation/ damage	Safety and security	Identified need	Maintenance required	Further investigations required	Illegal activities

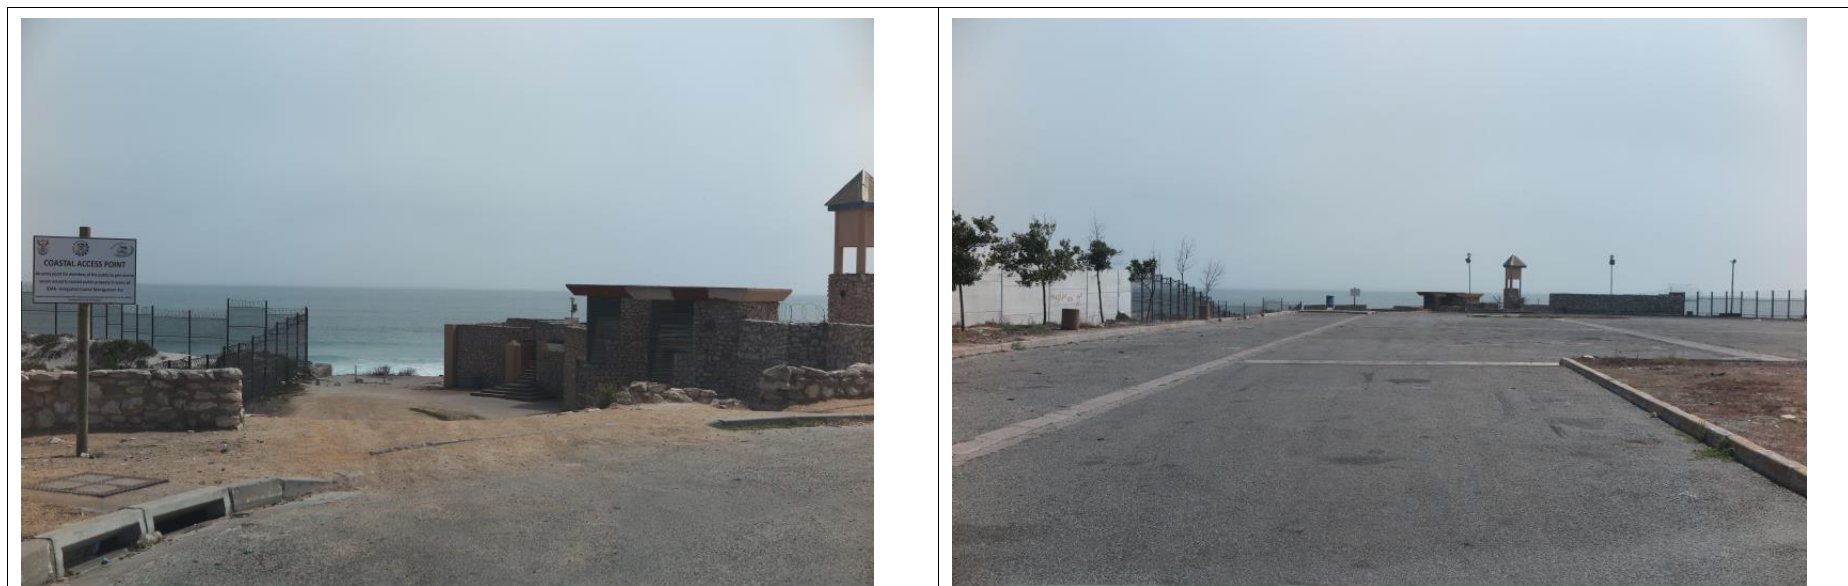
Town/area	Saldanha - Tabakbaai	Colour	Characterisation	Colour	Characterisation
		Access in conflict		Pedestrian access	
		Restricted Access		Nature reserve access	
		Vehicle access	X	No formal access	
Site Ref:	Sal 01				
Description:	Sandy beach- minimal dune structure and vegetation except to the north. Resort- access for vehicles and pedestrians.				
Facilities provided:	Parking, shelters, ablutions, picnic/ braai facilities				
Planned uses catered for:	Picnic, fishing, swimming, sight-seeing, braaing, walking dogs on leashes				
Concerns:	The Tabakbaai resort is not well maintained and the apron to the beach is crumbling. This can result in damage to the dune structure and should be repaired. Evidence of vehicles using this to obtain access to the beach was observed. This must be prevented.

Needs:	There is clearly a need for a resort in this location.					
Recommendations	The resort should be better maintained- especially at the seaward edge where the concrete apron has been eroded and is failing. This is a safety risk to visitors.					
Priority Action Items						
Conflict	Environmental degradation/ damage	Safety and security	Identified need	Maintenance required	Further investigations required	Illegal activities
		X		X

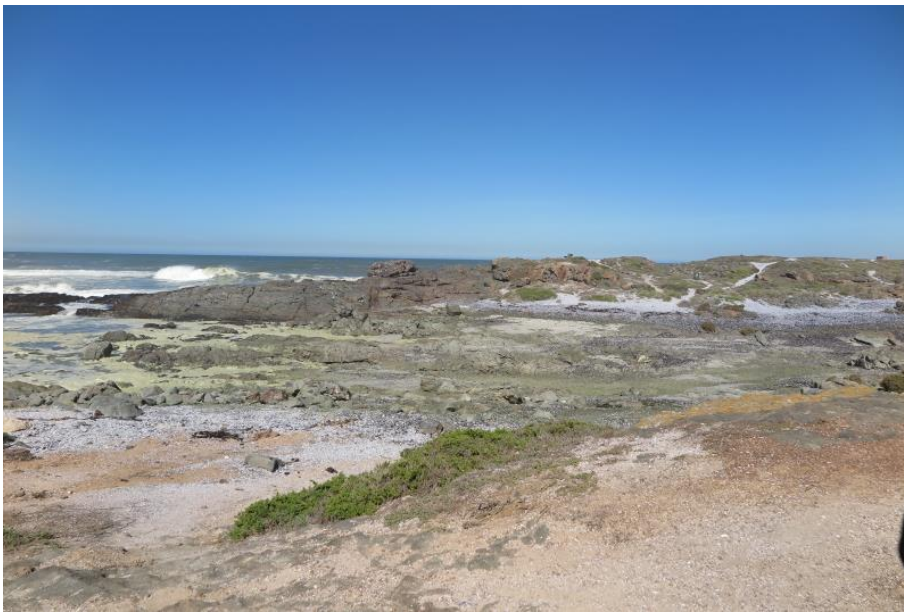
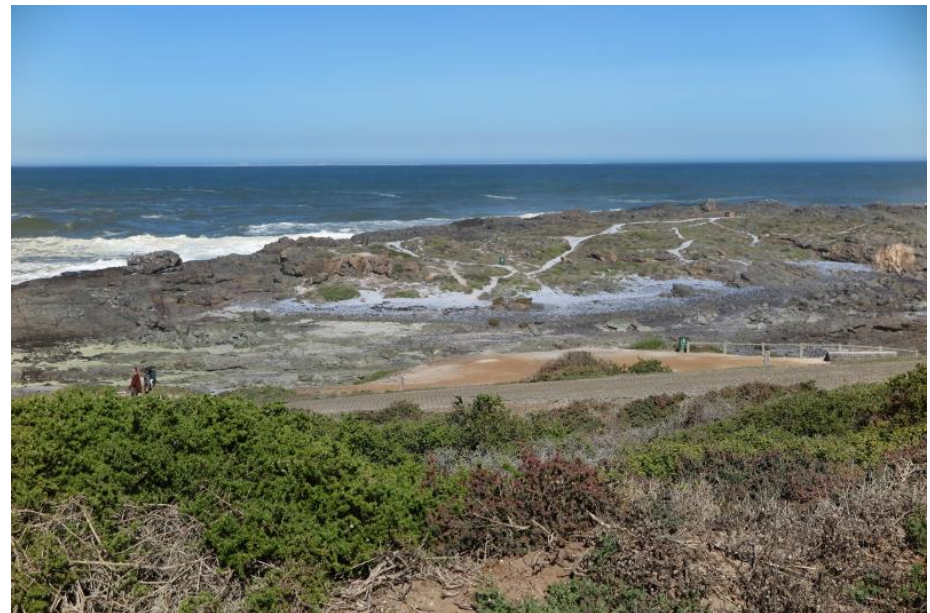
Town/area	Yzerfontein	Colour	Characterisation	Colour	Characterisation
		Access in conflict		Pedestrian access	
		Restricted Access		Nature reserve access	
		Vehicle access	X	No formal access	
Site Ref:	Yze 06				
Description:	<p>Low vegetated dunes between houses and sandy shoreline.</p> <p>Unrestricted vehicle and pedestrian access to the beach. The tarred road runs parallel to the sea south east to the end of Yzerfontein. There are numerous pull-off areas and formal paths to the beach. These formalised routes notwithstanding there are many informal paths from individual houses.</p>				
Facilities provided:	Tarred road, pull-off areas- look-out areas, refuse bins, benches, signage.				
Planned uses catered for:	Sight-seeing, walking, fishing.				
Concerns:	Proliferation of informal paths into dunes to the rocky shore immediately west of the harbour. This is resulting in damage to the vegetation.

Needs:	Nil					
Recommendations	Nil					
Priority Action Items						
Conflict	Environmental degradation/ damage	Safety and security	Identified need	Maintenance required	Further investigations required	Illegal activities

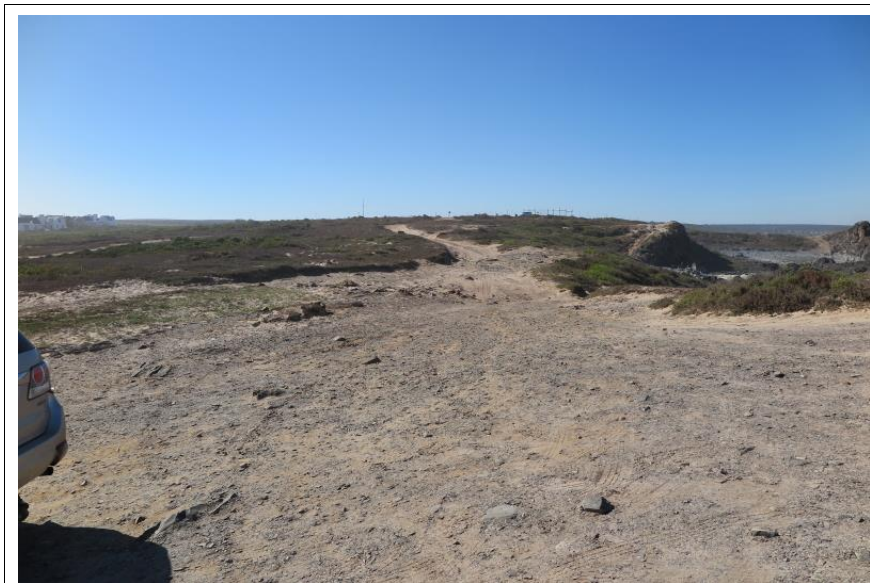
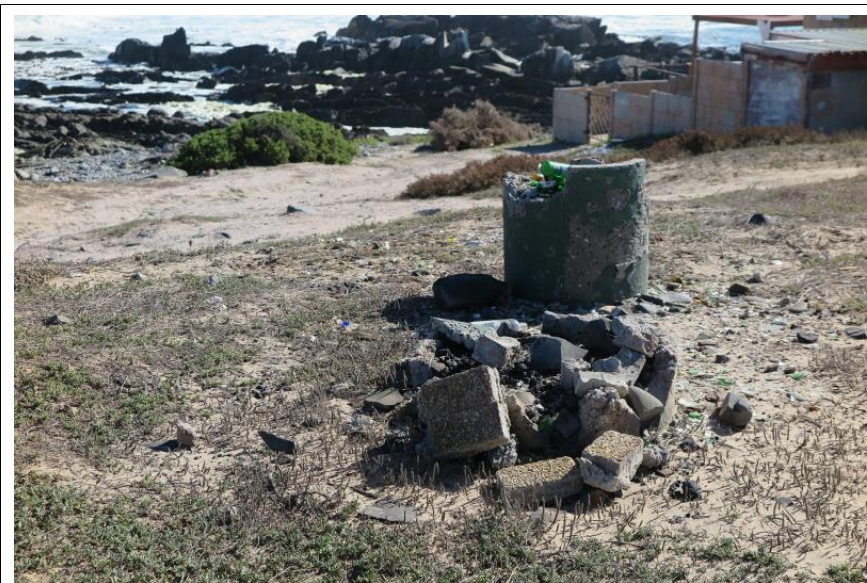
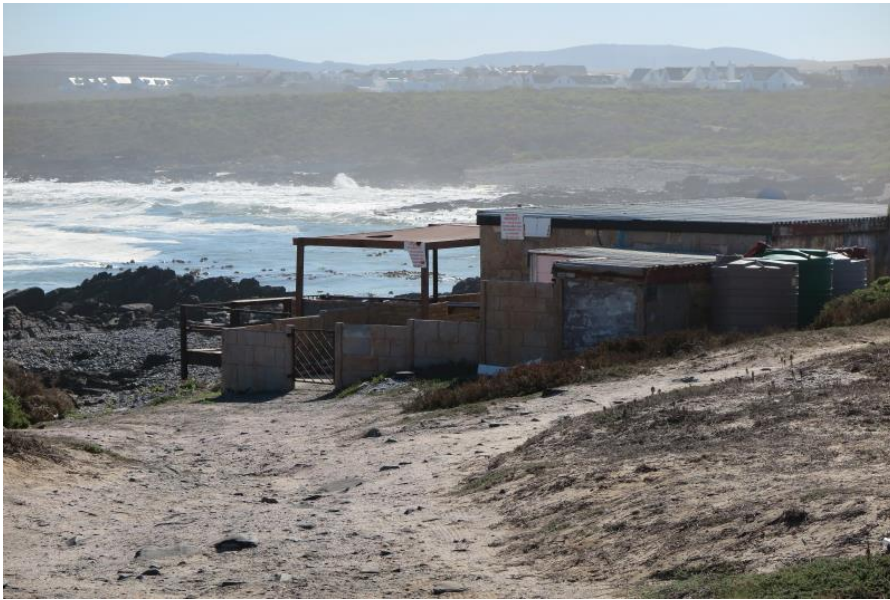
Town/area	Grotto Bay	Colour	Characterisation	Colour	Characterisation
		Access in conflict	X	Pedestrian access	
		Restricted Access		Nature reserve access	
		Vehicle access		No formal access	
Site Ref:	Gro 01				
Description:	<p>Rocky shoreline with low dune vegetation at the top of the rock platforms. Private dwellings inland.</p> <p>CapeNature reserve- limited public access. Gravel roads to rear dunes- no evidence of environmental damage. Housing estate</p> <p>Only a single gravel road to the south of the estate provides access to the CPP and parking area.</p> <p>The local residents have offered to assumed management control of the public parking area as a means to manage unruly behaviour. This is therefore considered a conflict site since there is conflict between residents and the public using the parking area.</p>				
Facilities provided:	Housing estate with gravel paths to the beach and rocky shores. Public parking area with limited amenities provided.

Needs:	Nil					
Recommendations	Limit tracks, maintain parking area and amenities.					
Priority Action Items						
Conflict	Environmental degradation/ damage	Safety and security	Identified need	Maintenance required	Further investigations required	Illegal activities
	X			X
